NDI No. PA 00220

ROYAL RESERVOIR DAM

PHASE I INSPECTION REPORT NATIONAL DAM INSPECTION PROGRAM

JULY 1980 03 136

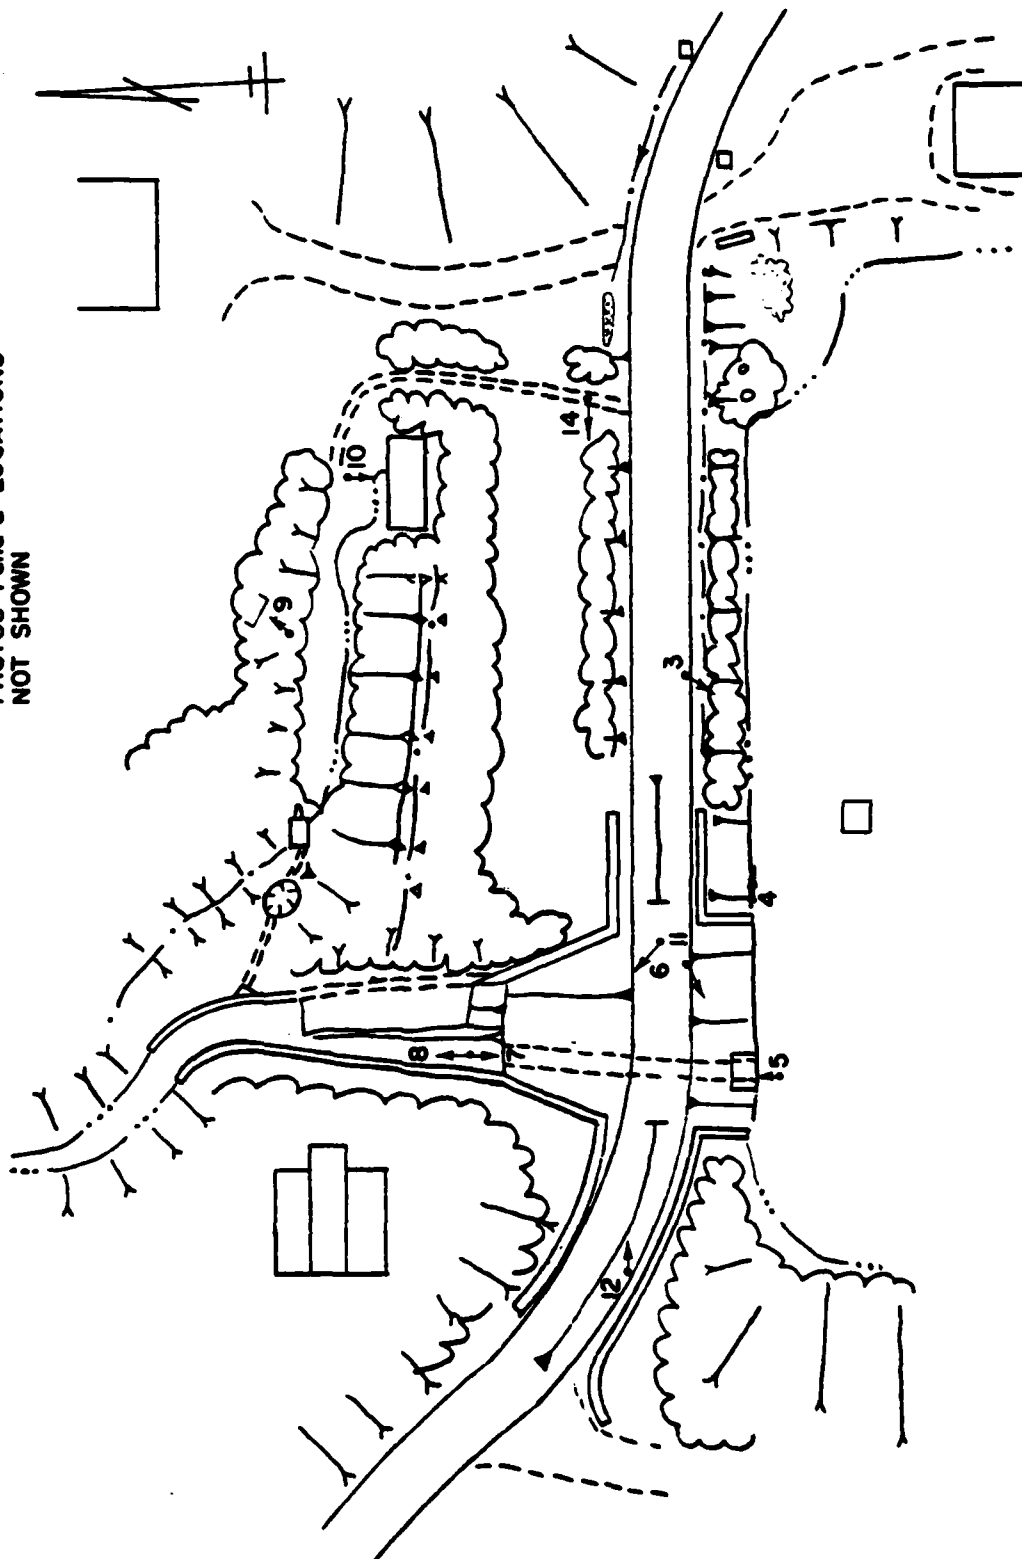
DATE: JULY 1980		ROYAL RESERVOIR DAM NATIONAL DAM INSPECTION PROGRAM		PHOTO KEY MAP
SCALE: NONE				
DR: JF	CK:	A. C. ACKENHEIL & ASSOCIATES, INC. CONSULTING ENGINEERS PITTSBURGH, PA., CHARLESTON, W. VA. & BALTIMORE, MD.		
DWG. NO.

PHOTOS 1 and 2 LOCATIONS
NOT SHOWN
